## Expert Report of Harri Kytomaa

**Expert Report of Harri  
Kytömaa in the Matter of  
Bates v Tippmann**

May 31, 2018

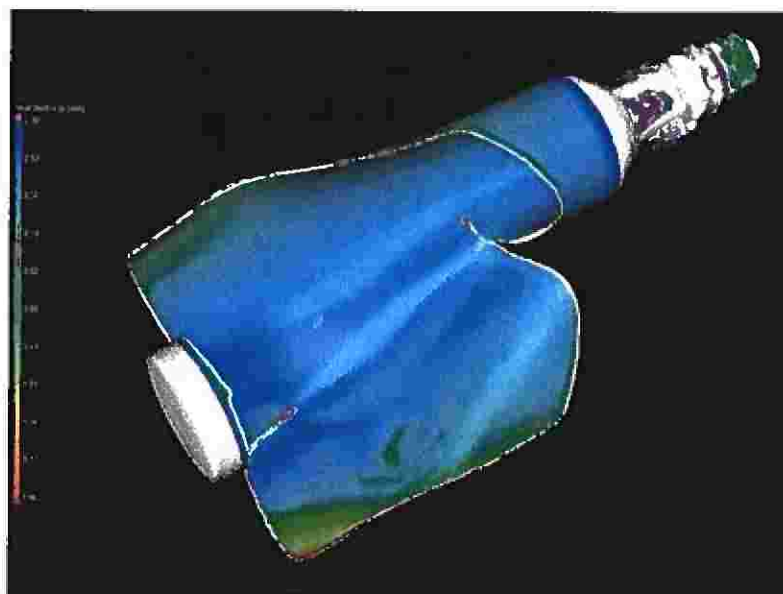
CT scanning of the entire subject bottle and exemplar bottles were performed. A three-dimensional rendering from the scan of the subject CO<sub>2</sub> bottle is shown in Figure 5. The measured wall thickness of the incident and exemplar bottles indicate a wall thickness of approximately 2.35 mm (0.093 inches) to 2.5 mm (0.098 inches) for both bottles.

Figure 5. Three-dimensional rendering of the subject CO<sub>2</sub> bottle from CT scan data.

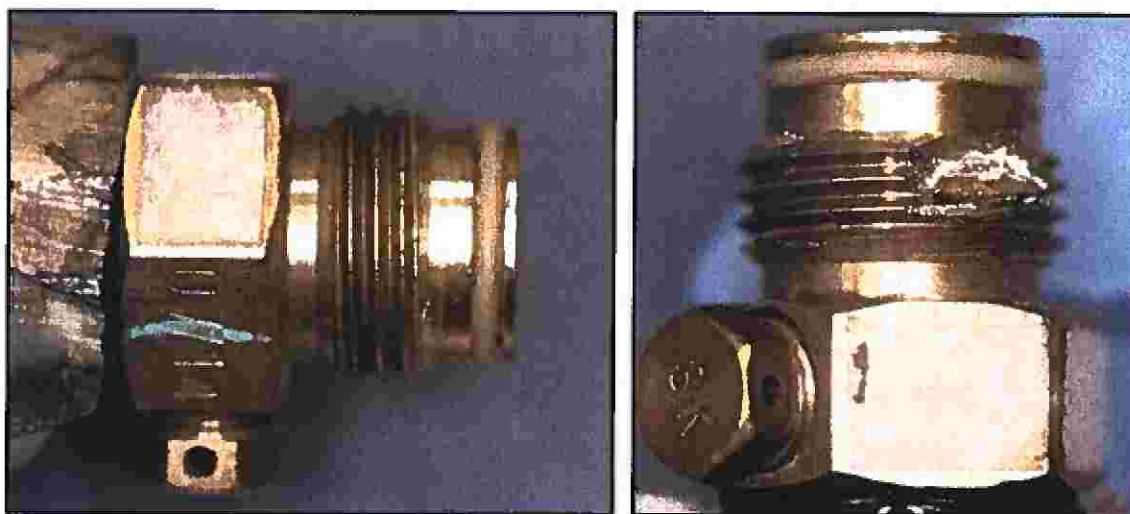
A visual inspection of the incident bottle was performed. A photograph of the ruptured bottle is shown in Figure 6. Photographs of the pin valve are shown in Figure 7. It was observed that the pin valve was dated 7/14 indicating a manufacture date in July 2014. Damage to the threads of the pin valve was also observed.

Figure 7. Photographs of the pin valve on the subject CO<sub>2</sub> bottle.

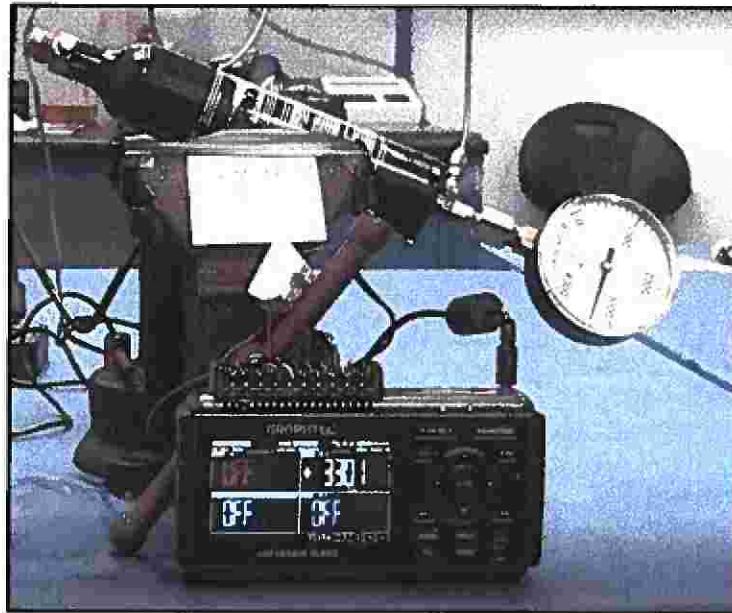
Hydrostatic pressure testing was performed with a Fluke 700HTP2 hydrostatic pressure tester. An image from the recorded test video can be seen in Figure 14.

Figure 14. Image from test video of the hydrostatic testing of the subject PRD. The pressure gauge and data acquisition system indicate a pressure of approximately 3,300 psi.

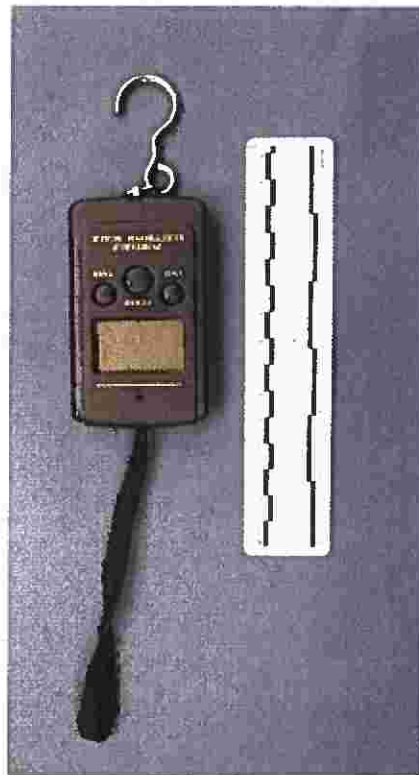
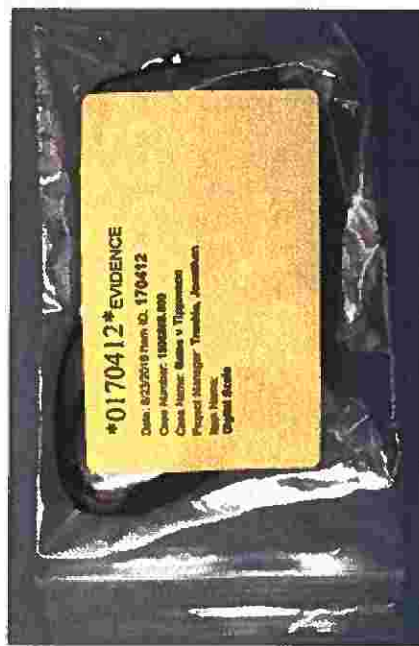
Figure 3 – Scale owned by Bates.

- 3) Testing of the scale owned by Bates (see Figure 3). The weight reported by the scale will be documented by photographs after hanging weights totally 5 oz, 9 oz, and 13 oz.

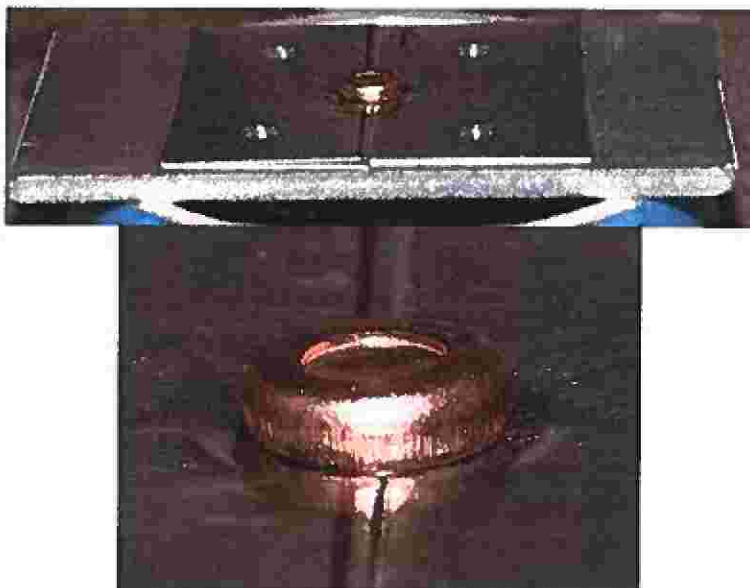
**Cap removal setup with top plate removed to show the thin metal lips located underneath the cap.**
